Level 3 Building Survey Report

Building Survey...

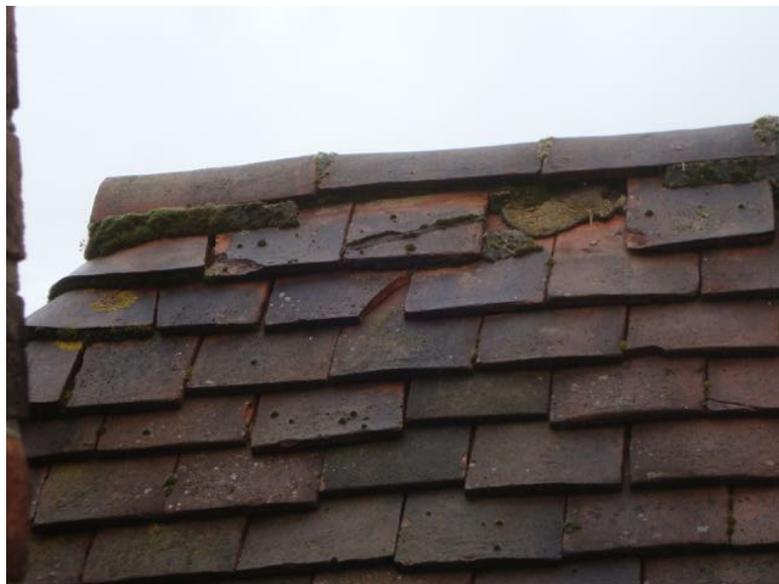
The tiling appears to be in generally satisfactory condition bearing in mind its age. The tiles do not appear to have been renewed and therefore have lasted well beyond the normal life expectancy of sixty years for this type of tile. The tiling is beginning to deteriorate and several tiles have slipped from their positions or are showing signs of shaling. The mortar in which the ridge and hip tiles are bedded is weathered and I suspect that many of them will need to be rebedded to ensure that they remain fixed.

**TYPICAL EXAMPLE OF DEFECTIVE TILING TO ROOF
AND RIDGE**

In the short term, I recommend that you engage a roofing specialist to replace all missing or defective tiles with sound matching tiles. I cannot rule out that further defects may become apparent from a closer inspection and whilst wholesale recovering is not required at present, it would be prudent to budget for this eventuality in the next few years. Any work to the roof slopes will require scaffolding for Health and Safety reason and this will add to the cost.

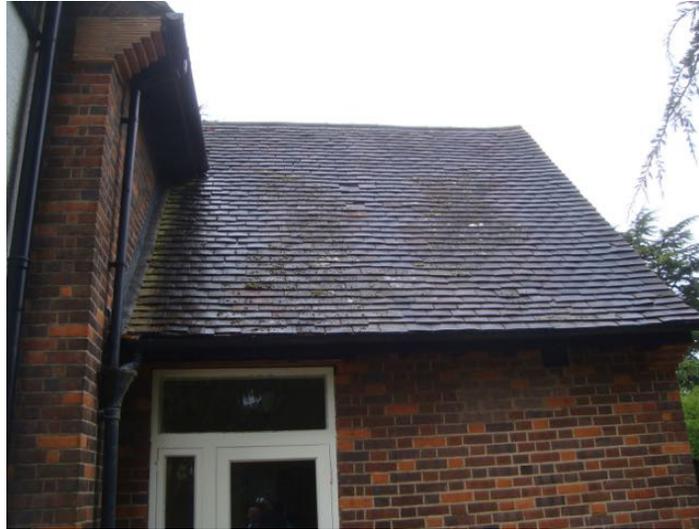
The general condition is similar to the main roof in that several tiles have begun to deteriorate and some have slipped from their positions. I recommend that you engage a reputable roofing contractor to carry out the necessary work to replace defective tiles and rebed the ridge tiles if required.

TILING ON BOILER ROOM AND UTILITY ROOM ROOF

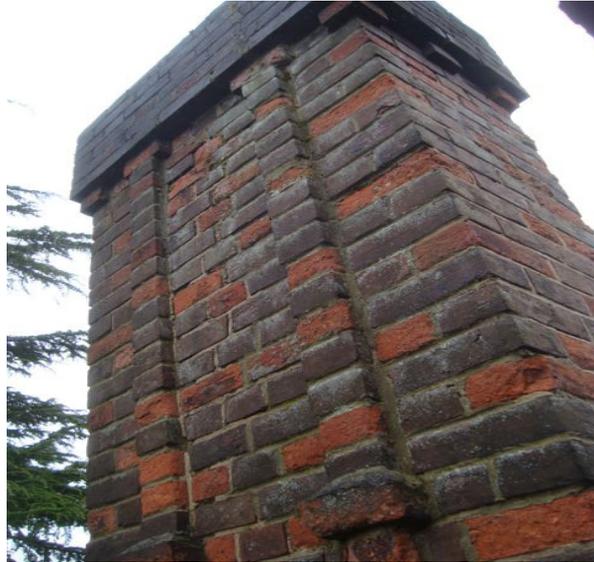
The stacks are tall structures with over sailing courses at the top of each stack to shed water away from the lower parts. No major defects were noted from a ground level inspection. However, some defects are apparent from a close inspection of the front left stack particularly in relation to the erosion of the bricks and the mortar joints. It would be possible to cut out the weathered bricks and build in new matching bricks but this would be time consuming. The weathered mortar joints should be raked out and repointed.

WEATHERED BRICKWORK TO FRONT LEFT HAND CHIMNEY

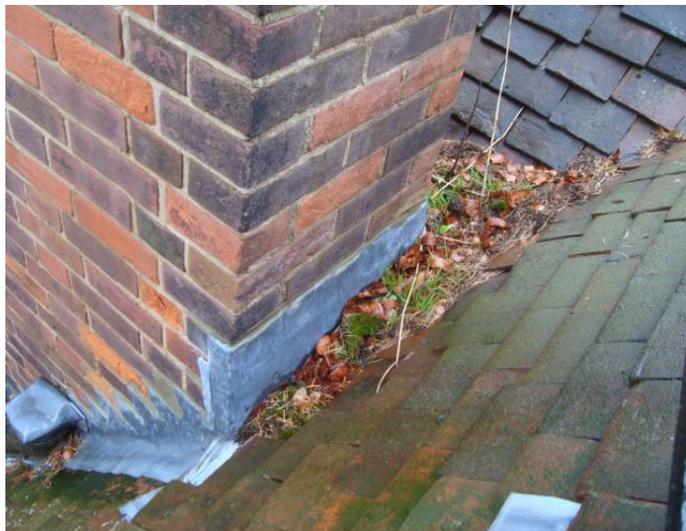
The lead flashings around the stacks are generally sound where visible. There is a considerable build-up of debris behind the front left hand stack and this should be removed when the roof slopes are overhauled. Regular cleaning of the valleys and roof slopes will prevent debris building up in the future.

DEBRIS BEHIND FRONT LEFT HAND CHIMNEY STACK

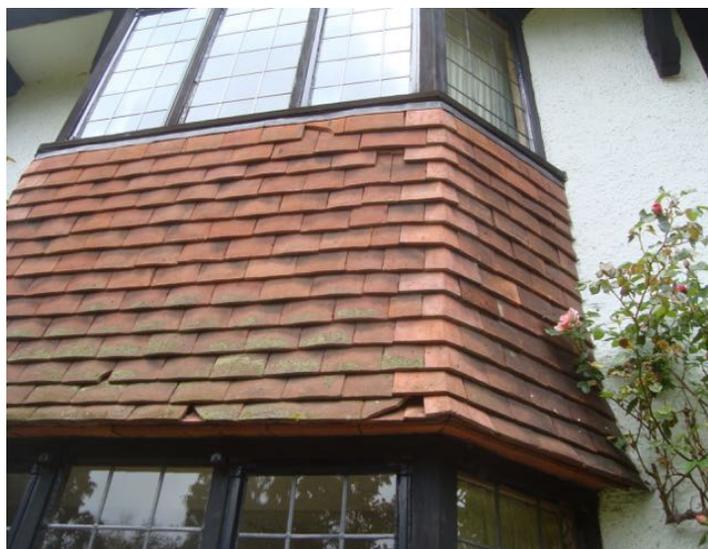
The tile hanging to the bay windows is generally sound but several tiles have either fallen off or are chipped. I recommend that the tiling to all the bays is overhauled to replace all defective tiles with sound matching tiles.

**DEFECTIVE TILING HANGING TO
LEFT HAND REAR BAY**

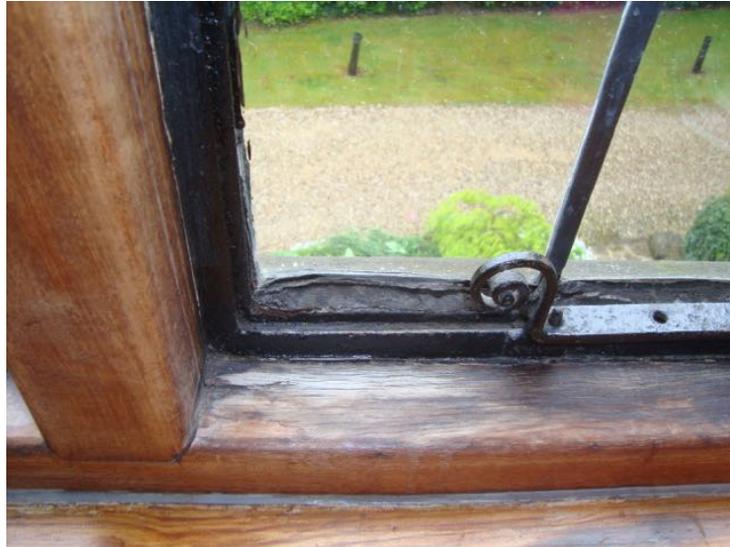
The original windows still exist and consist of hardwood frames with iron frames having hinged sashes with leaded lights. The majority of the windows are generally sound bearing in mind their age but some defects have occurred as the metal frames are not galvanised. This has resulted in rusting which has caused expansion of the metal which results in loose putty and panes. The worst example is in the store off the secondary staircase. It may be possible to repair this window but if not, a galvanised frame should be obtained if the right size can be found. A specialist glazing company may be able to assist in this regard.

RUSTED WINDOW FRAME AND LOOSE PANE OF GLASS TO STORE WINDOW

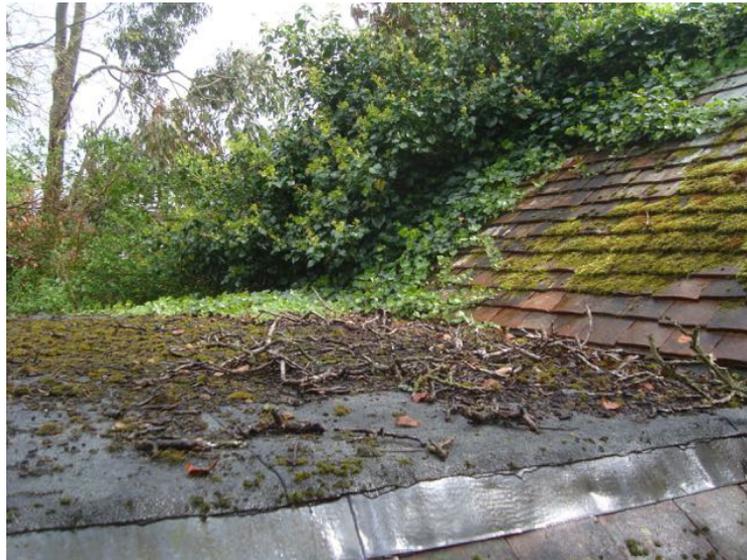
DEBRIS AND IVY ON OUTBUILDING ROOF

The ivy and all other debris should be removed from the walls and roof slopes. The tiling should be overhauled and the guttering cleared of debris and repaired as required. I recommend that you engage a reputable roofing contractor to carry out the work.

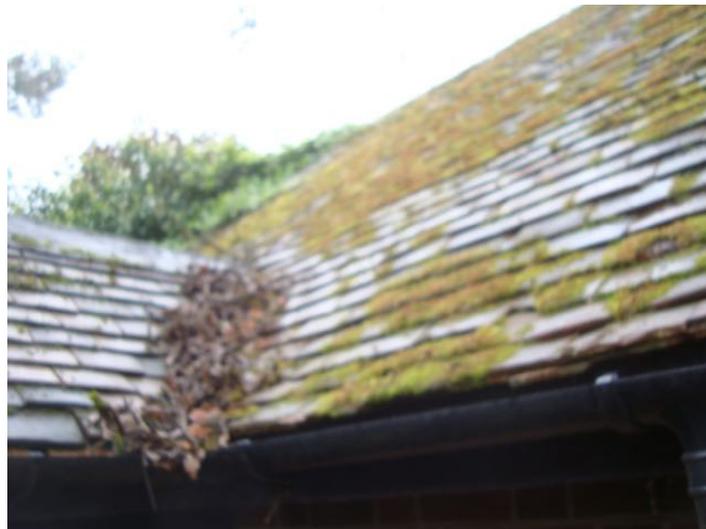
**DEBRIS IN VALLEY AND MOSS ON
OUTBUILDING ROOF**

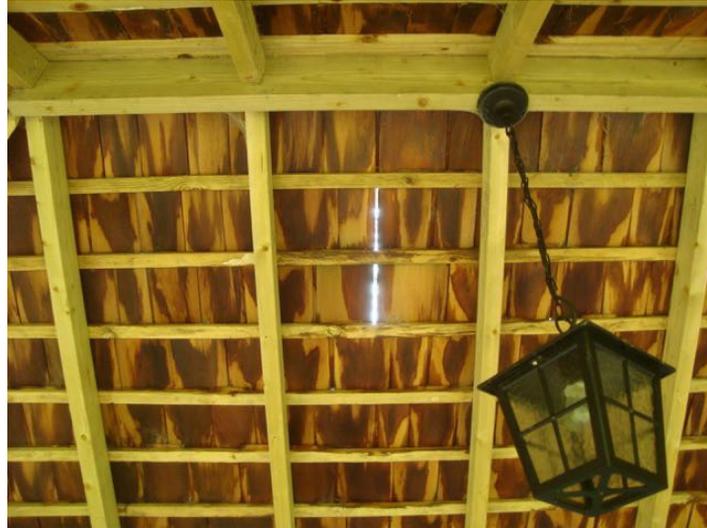
The gazebo has been built in recent years and comprises a timber framed structure supporting a timber roof covered with cedar shingles. The general condition is satisfactory but a few shingles have slipped from their

positions resulting gaps in the covering. I recommend that the roof is made good as soon as possible.

GAP IN SHINGLES TO GAZEBO ROOF

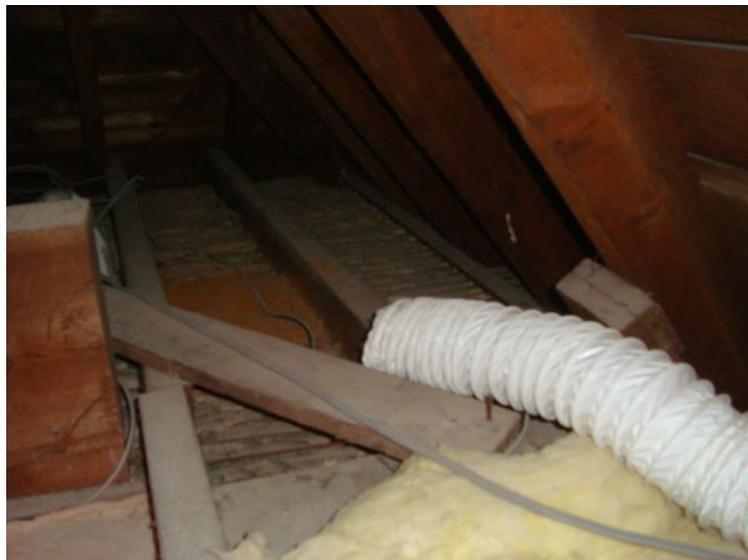
The second floor bathroom fittings consist of a vitreous enamelled pressed steel bath, a vitreous china basin, a vitreous china toilet and cistern and a tap-mounted shower over the bath. The fittings are in satisfactory condition but the shower was not tested. The room is fitted with an extract fan but it exhausts into the roof space above. Ideally it should exhaust to the exterior to avoid humid air entering the roof space.

**SECOND FLOOR BATHROOM EXTRACT DUCT
VENTING INTO ROOF SPACE (LACK OF INSULATION
ALSO VISIBLE)**
