[CLIENT NAME]	[PROPERTY ADDRESS]
SPECIALIST PROPERTY SURVEYORS IN ALL ASPECTS OF DAMP AND TIMBER DEFECTS	Our Ref: Date:
Dear Mr & Mrs

## **The Instruction**

I was instructed by Mr & Mrs via e-mail on Friday 26<sup>th</sup> February 2021 to inspect the stated property regarding internal dampness and timber defects.

• Is a one bedroom, solid brick constructed, ground floor flat within a mid-terrace row built circa late 1800s/early1900s.

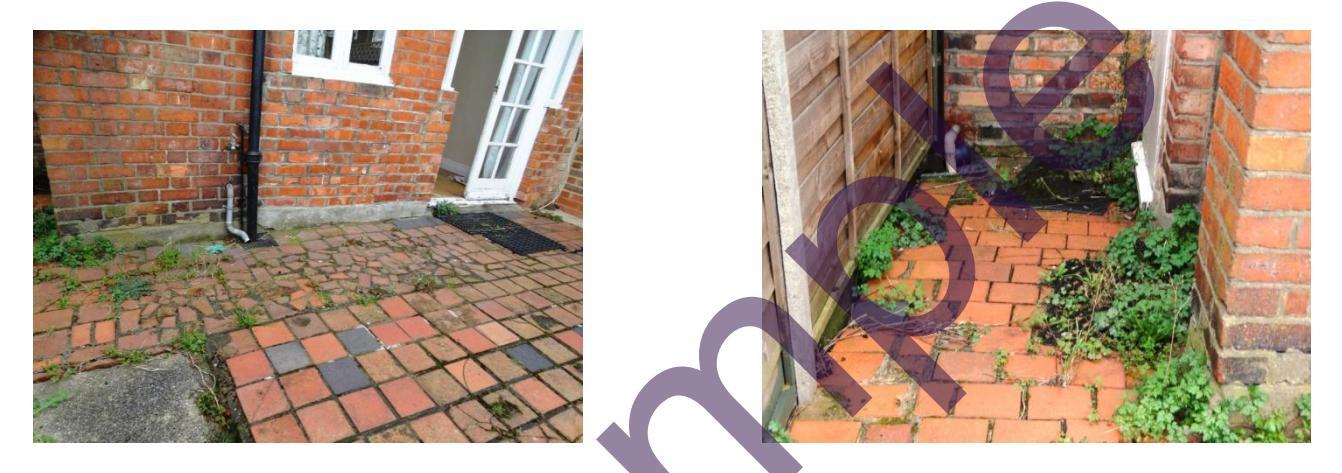
• An inspection externally revealed that high external ground levels do exist **across and around the rear and back-addition walls** as seen in the selective photographs below in relation to where I would expect the damp proof course to be located in the structural brickwork.

The effects of dampness rising from the ground actually or potentially should be resolved by freeing the existing damp proof course of impediment to allow it to fully function as designed.

The channel should then be back-filled using pea-shingle (but not above the damp proof course) to depressurize moisture bearing against the base of the wall and enhance drainage.

Using pea-shingle will remove the effects of rainwater splash-back as it is not a hard dense material. If a trip hazard is created between the top of the newly installed shingle and retained ground levels then large stones sourced from a garden centre or similar can be laid over the shingle.

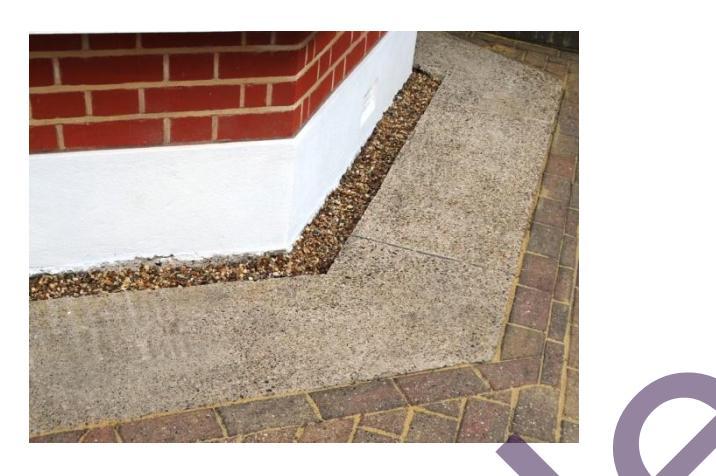
• An example of external ground level reduction works as seen in the selective photograph below.

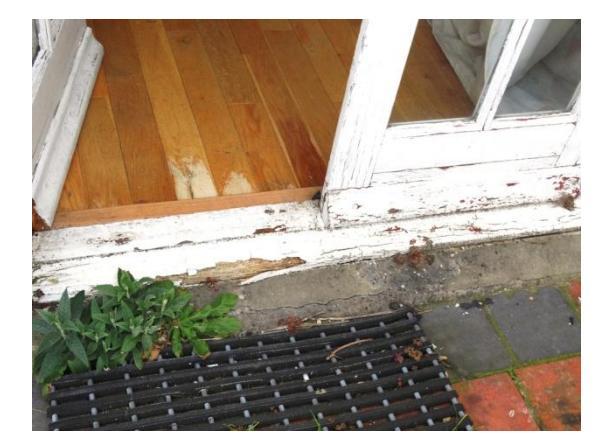
• Poorly maintained and degraded external joinery as seen in the selective photograph below.

**Certainly** there is a need to repair/renew items of external joinery.

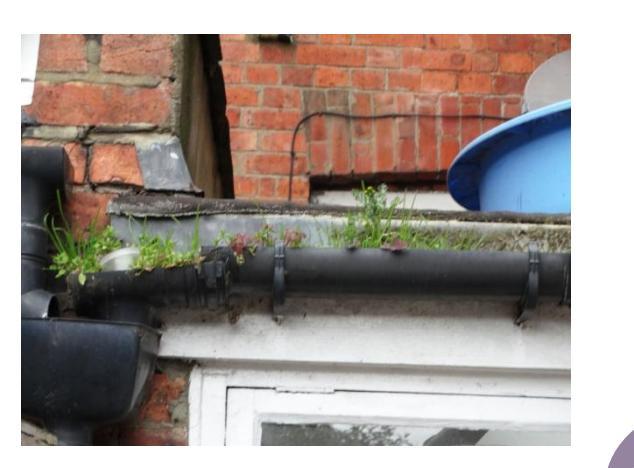
• Blocked rainwater goods as seen in the selective photograph below.

**Certainly** there is a need to repair/renew/clear items of rainwater goods.

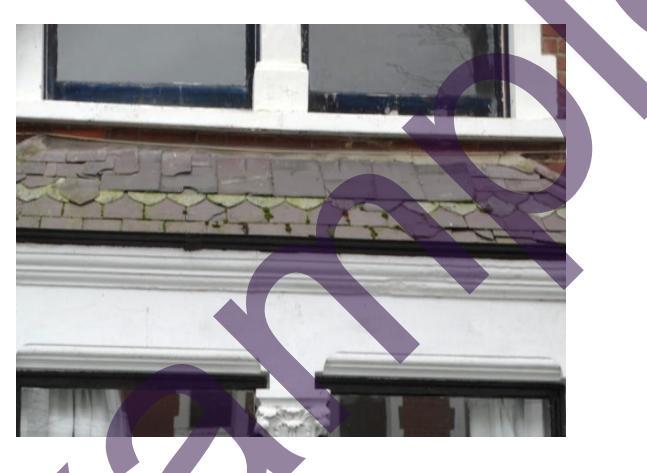
• Broken roof tiles as seen in the selective photograph below

**Certainly** there is a need to repair/renew the single storey front bay roof coverings and possibly the flat roof coverings over the kitchen although whilst conjecture any defects here are thought historic.

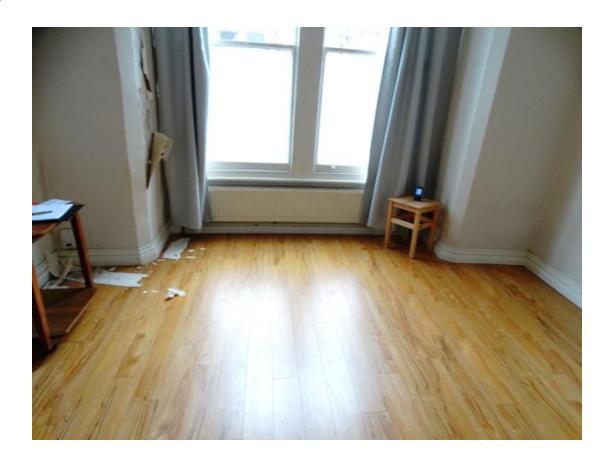
• Over and across the front bay wall within the front reception room where elevated readings were recorded together with degradation of the wall finishes as seen in the selective photograph below synonymous that they have reached the end of their useful life but exacerbated by longstanding inherent penetrating damp.

All degraded plaster should be removed to a minimum height of 1.2m and if necessary 300mm further past any last evidence of degradation in all directions to compensate for capillary retained moisture movement within the walls.

- Re-plastering should be carried out using clean washed sharp sand and Sulphate resistant cement in the ratio of 3:1 with the inclusion of a waterproofing/salt inhibitor additive and skim plaster finished which satisfies the requirements for "M" Grade (Table 5) laid down in British Standard 882 (1993).
- Alternatively where practically possible dry-linings are best applied although these normally require full height application mainly for reasons of thickness continuity.
- Under no circumstances should gypsum based plasters be used as backing coats as these are notorious for their moisture and salt retention capabilities.

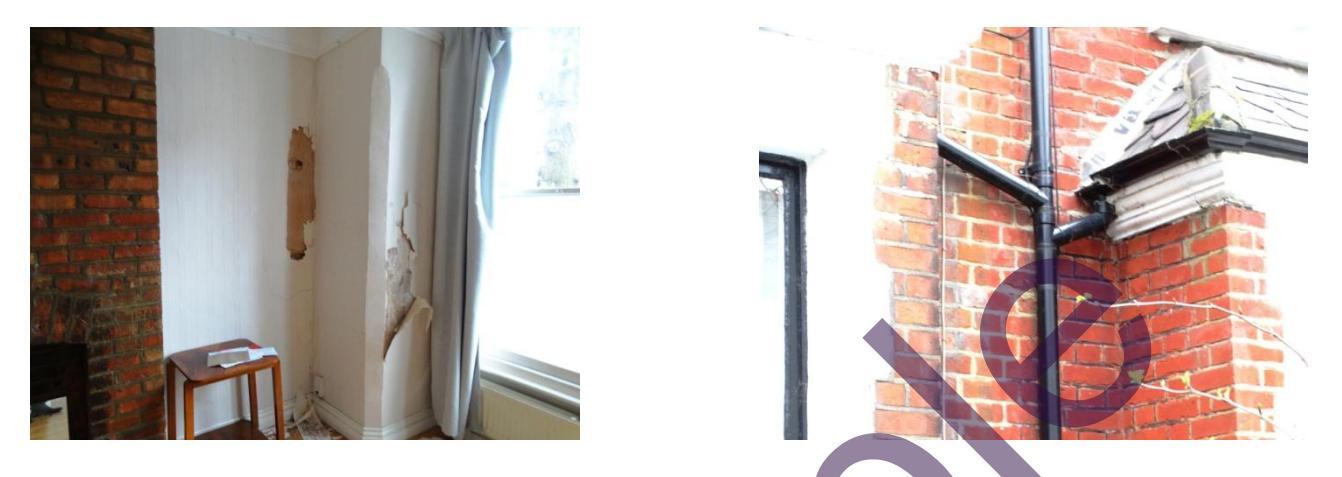
• Over and across the front alcove within the front reception room where elevated readings were recorded together with advanced degradation of the wall finishes synonymous that they have reached the end of their useful life but exacerbated by longstanding inherent penetrating damp notably the external rainwater goods which have indicatively been replaced in recent times as seen in the selective photographs below.

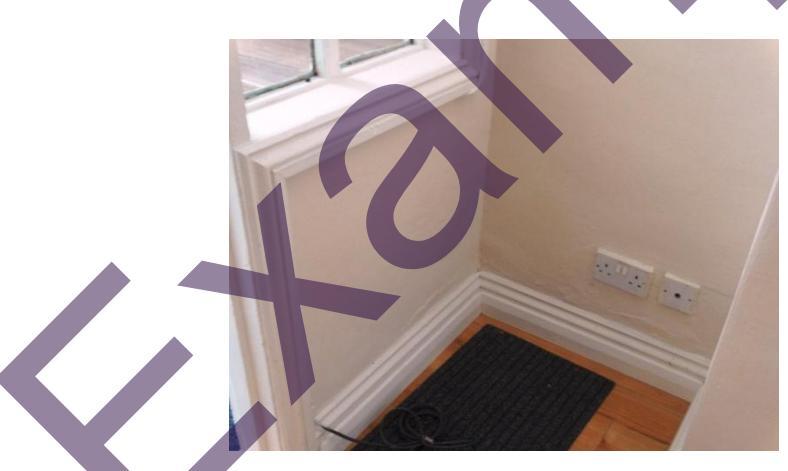
• Over and across the rear alcove within the dining room where elevated readings were recorded together with advanced degradation of the wall finishes as seen in the selective photograph below synonymous that they have reached the end of their useful life but exacerbated by longstanding inherent penetrating damp and previous less than perfect repairs.

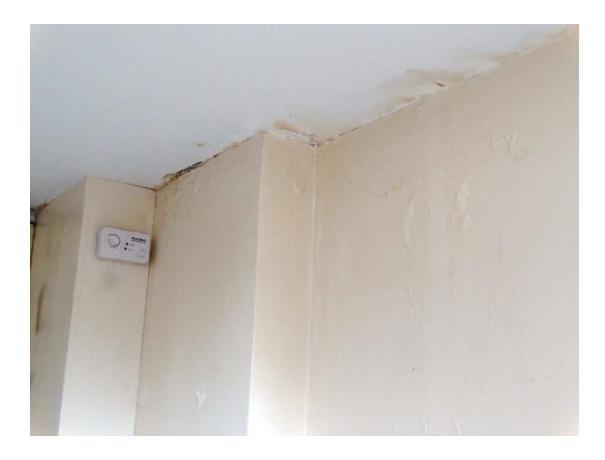
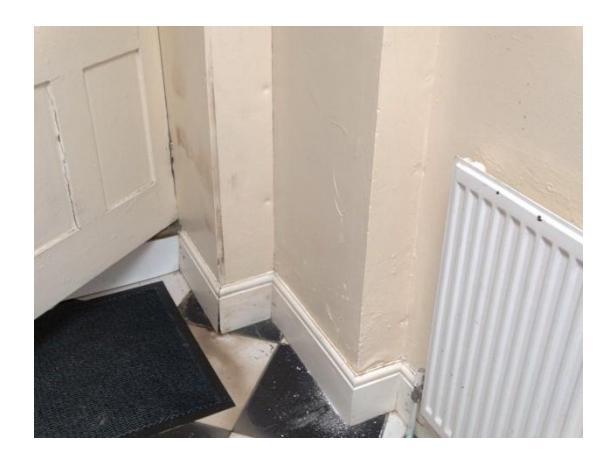
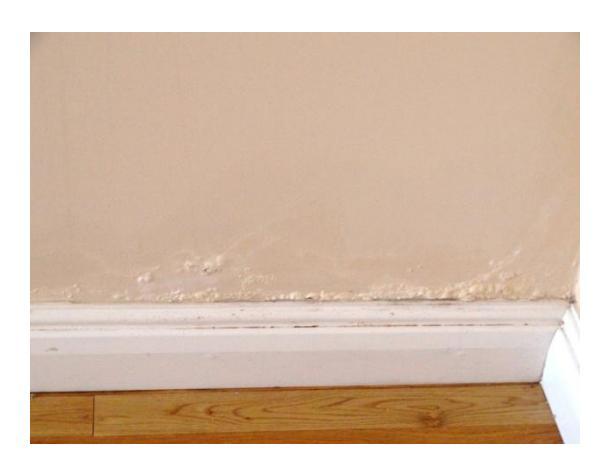
Over and across the rear section dividing wall on both the kitchen and bedroom sides where elevated readings were recorded together with degradation of the wall finishes as seen in the selective photographs below synonymous with water ingress from the flat roof above.
