Level 3 Building Survey Report

Building Survey...

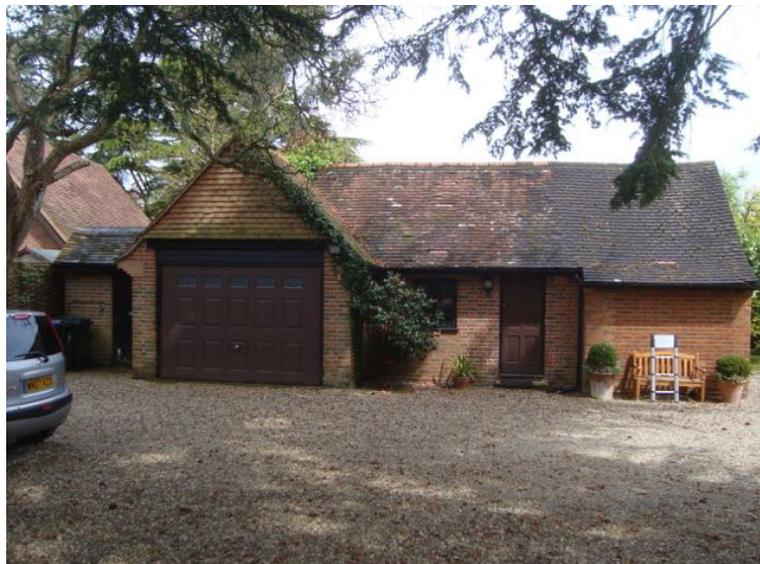
ELEVATION OF OUTBUILDING

The basic structure of the building appears to be in satisfactory structural condition. The internal alterations to form the self-contained flat have been carried out to a satisfactory standard but I understand that the work was not signed-off by the Council. If you require a Completion Certificate, I recommend that you approach the Local Authority to ascertain whether the Building Control Department is prepared to issue a Certificate. They may require a fee and a site inspection in order to do this.
